Manhole Inspection Summary

Manhole # S35S__058MH

Insp Date: 1/30/08 11:48 AM

Location Address: **ropewalk ln**

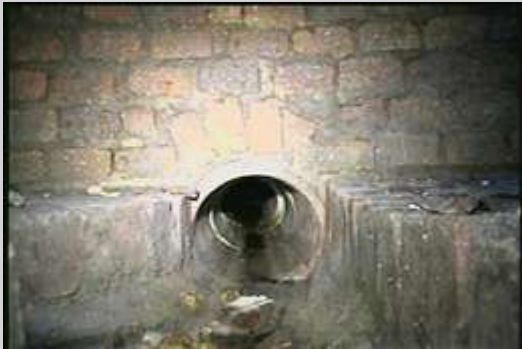
12 O'Clock Outflow

8 in. Circular Gravity Sewer
Pipe Out @ 12 O'Clock

Pipe Material: **Clay** ☐ Pipe Lined

Invert Depth: **9.70** (ft.) Flow Characteristics: **Slow**

Deposits: ☒ None ☐ Mud ☐ Sludge ☐ Debris ☐ Grease

Infiltration: **None** Pipe Seal Cond: **Unknown**

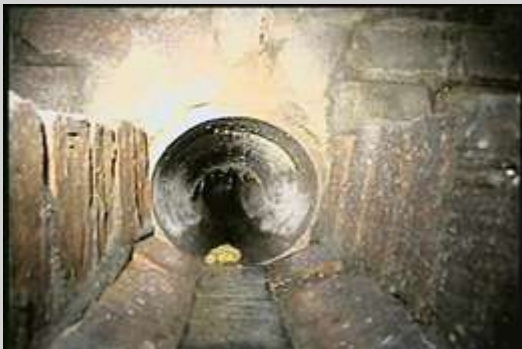
6 O'Clock Inflow

8 in. Circular Gravity Sewer
Pipe In @ 6 O'Clock

Pipe Material: **Clay** ☐ Pipe Lined

Invert Depth: **9.20** (ft.) Flow Characteristics: **Slow**

Deposits: ☒ None ☐ Mud ☐ Sludge ☐ Debris ☐ Grease

Infiltration: **None** Pipe Seal Cond: **Unknown**

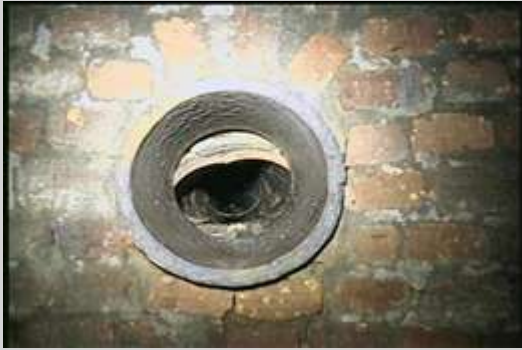
9 O'Clock Inflow

Pipe In @ 9 O'Clock

Pipe Material: **Clay** ☐ Pipe Lined

Invert Depth: **8.80** (ft.) Flow Characteristics: **Slow**

Deposits: ☒ None ☐ Mud ☐ Sludge ☐ Debris ☐ Grease

Infiltration: **None** Pipe Seal Cond: **Unknown**

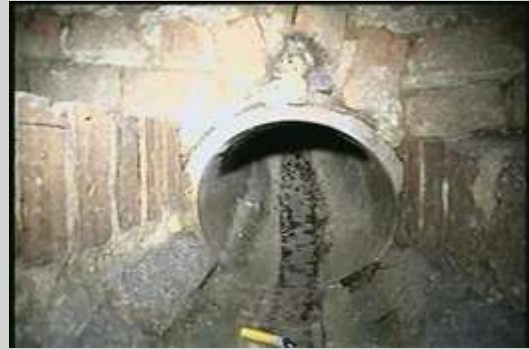
Drop In @ 9 O'Clock

Drop: **Outside** Direct

Inv Depth: **9.40** (ft.)

Drop Condition: **Open**
